Brick 2 Beam
Home Inspection

HOME INSPECTION REPORT

1234, Sample Dr, WA 98045

Friday, May 22, 2015

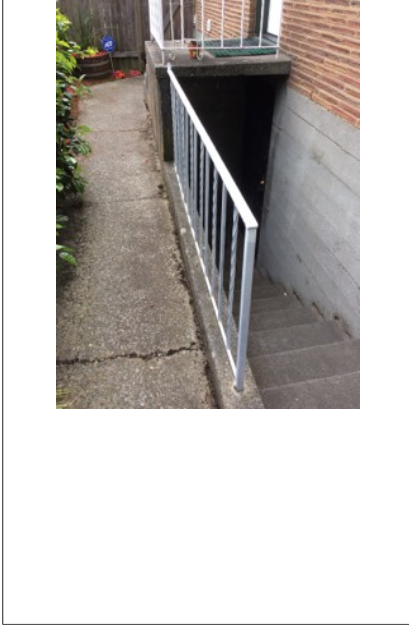
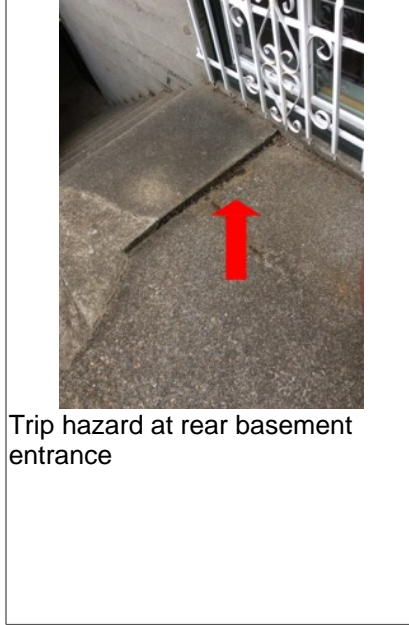
Service Walks

Material Concrete
Condition Marginal Trip hazard Settling cracks
Photos

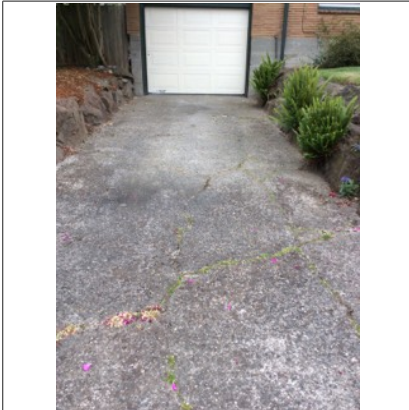
Driveway/Parking

Material Concrete
Condition Marginal Typical cracks Fill cracks and seal
Photos

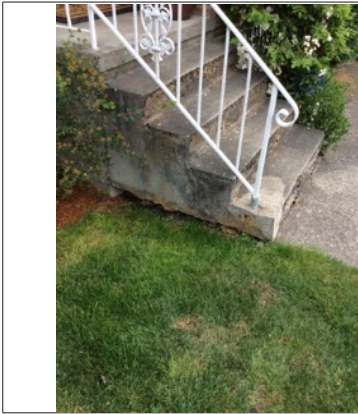
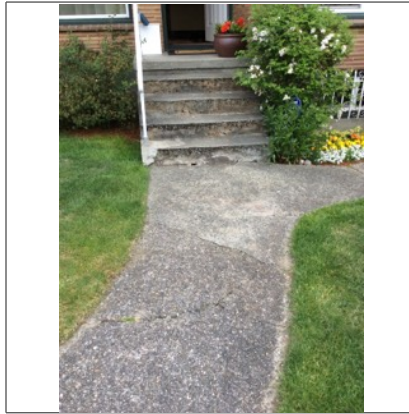
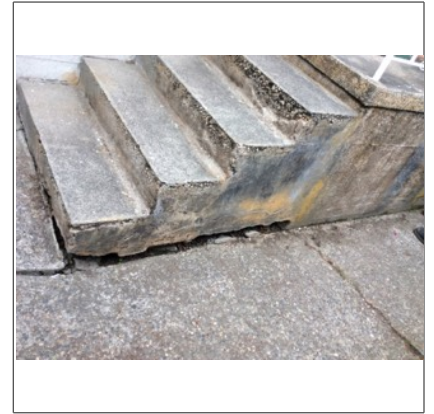
Stoops/Steps

Material Concrete
Condition Poor Cracked
Comments Steps should be back filled and supported from underneath to prevent future cracking and damage

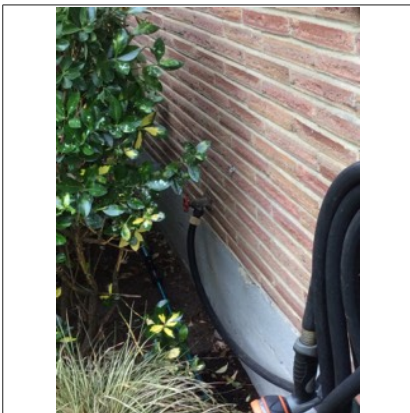
Hose bibs

Condition Satisfactory Marginal Recommend Anti-siphon valve

Comments Hose bib(s) not equipped with anti-siphon devices, possible cross connection can occur with anti-siphon device, recommend installing
Hose bib connection to exterior wall is loose, recommend repair

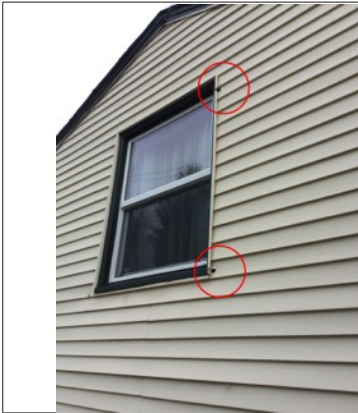
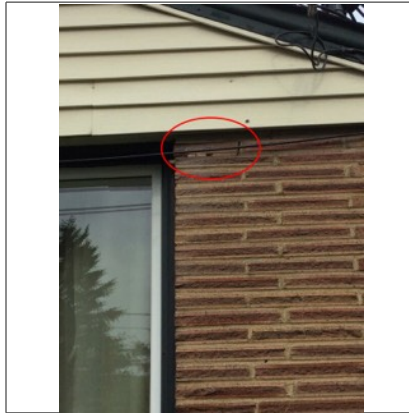
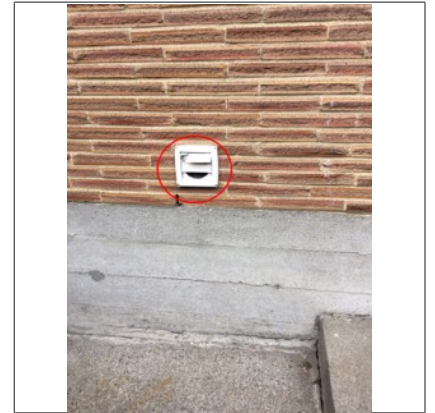
Material Block/Brick Metal/Vinyl Loose/Missing/Holes
Condition Satisfactory Recommend repair/painting
Comments Siding had some damage, recommend repairing/replacing damaged sections
Photos

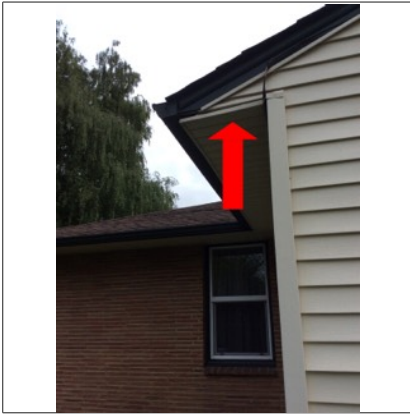
Soffit

Material Vinyl
Condition Satisfactory
Comments Holes/damage, recommend repair

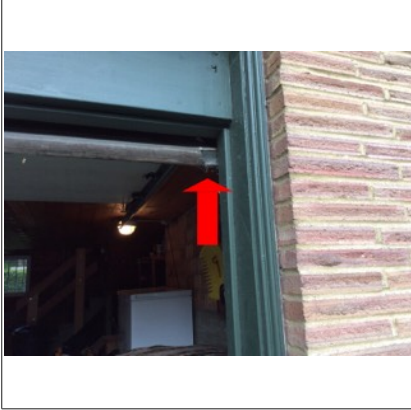
Garage/Carport

Comments Garage weather stripping damaged at areas, recommend repair

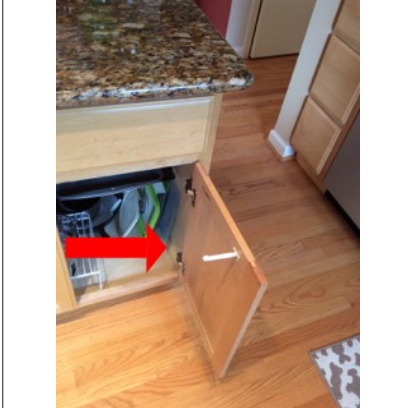
Cabinets

Comments Recommend hinges be tightened.

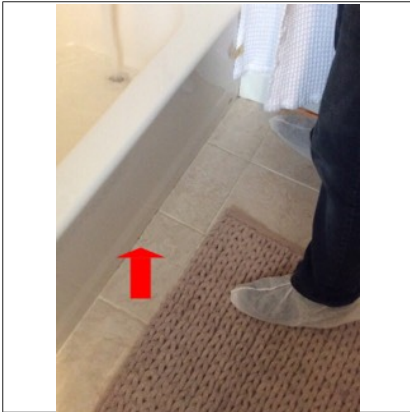
Bathroom

- Location** Main floor
- Sinks** Faucet leaks: Yes No Pipes leak: Yes No
- Tubs** Faucet leaks: Yes No Pipes leak: Yes No Not Visible
- Showers** Faucet leaks: Yes No Pipes leak: Yes No Not Visible
- Toilet** Bowl loose: Yes No Operable: Yes No
- Whirlpool** No
- Shower/Tub area** Fiberglass Condition: Satisfactory Marginal Poor Rooted floors
Caulk/Grouting needed: Yes No
Where:
Caulk recommended at Floor to tub junction
- Drainage** Satisfactory
- Water flow** Satisfactory
- Moisture stains present** No
- Doors** Satisfactory
- Window** Satisfactory
- Receptacles present** Yes Operable: Yes No
- GFCI** No Recommend GFCI
- Open ground/Reverse polarity** Yes
- Heat source present** Yes
- Exhaust fan** Yes Operable: Yes No
- Photos**

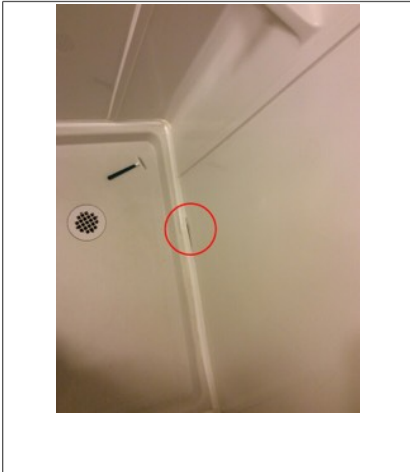
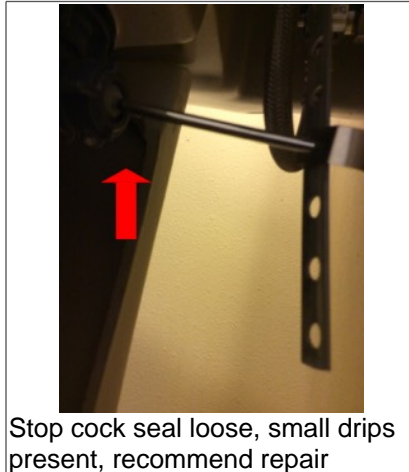
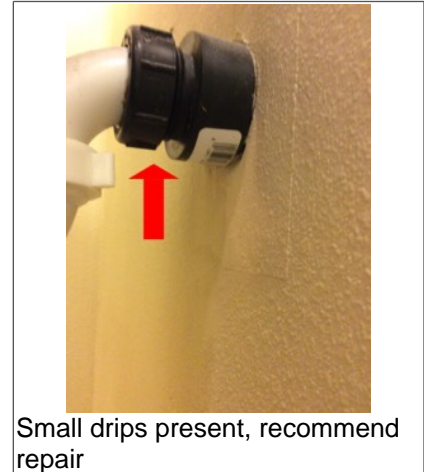
Bathroom (1)

Location Basement
Sinks Faucet leaks: Yes No Pipes leak: Yes No
Tubs N/A
Showers Faucet leaks: Yes No Pipes leak: Yes No Not Visible
Toilet Bowl loose: Yes No Operable: Yes No
Whirlpool No
Shower/Tub area Ceramic/Plastic Condition: Satisfactory Marginal Poor Rooted floors
 Caulk/Grouting needed: Yes No
Drainage Satisfactory
Water flow Satisfactory
Moisture stains present No
Doors Satisfactory
Window None
Receptacles present Yes Operable: Yes No
GFCI No Recommend GFCI
Open ground/Reverse polarity No
Heat source present No
Exhaust fan No
Comments Pipes are leaking - recommend repair and/or replacement
 Recommend caulking/grouting in shower/tub area
 Exhaust fan not present.

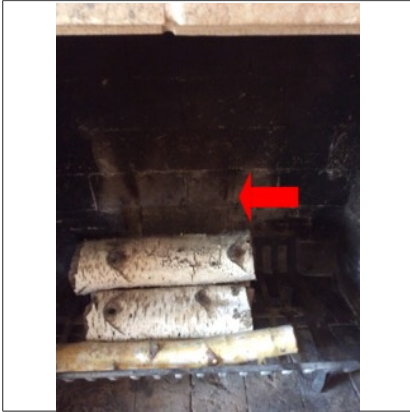
Fireplace

Location(s) Living room
Type Wood
Material Masonry
Miscellaneous Damper operable: Yes No Open joints or cracks in firebrick/panels should be sealed
Damper modified for gas operation N/A
Hearth extension adequate Yes
Mantel Secure
Physical condition Satisfactory Recommend having flue cleaned and re-examined
Photos

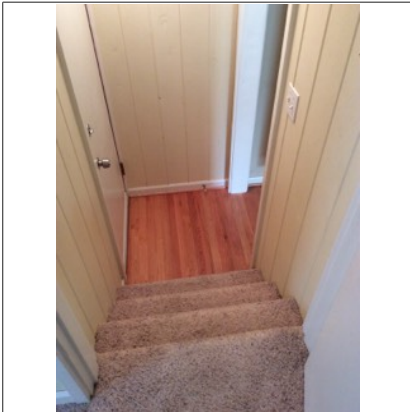
Stairs/Steps/Balconies

Condition Satisfactory
Handrail Safety hazard Hand Rail/Railing/Balusters recommended
Risers/Treads Satisfactory
Comments Handrail missing, potential safety issue. Recommend installing handrail
Photos

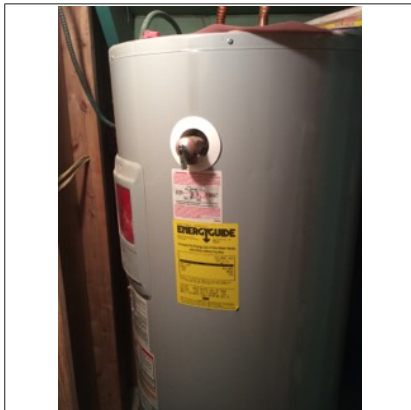
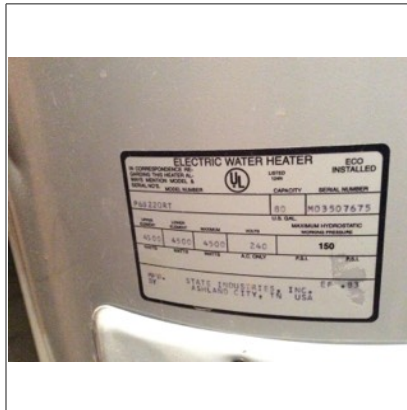
Water heater #1

Relief valve Yes Extension proper: Yes No Missing Recommend repair Improper material

Comments Water heater nearing end of manufacturers recommend life, recommend repair
Temperature-Pressure relief valve extension should be 4"-6" off of the floor - this is a Safety Concern.

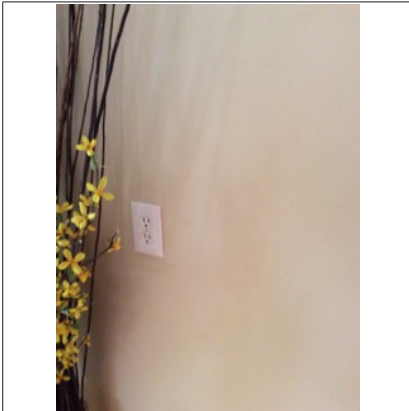
Living Room

Loose receptacle, recommend re-tighten/repair
