Brick 2 Beam
Home Inspection

HOME INSPECTION REPORT

1234, Sample Dr, WA 98045

Friday, May 22, 2015

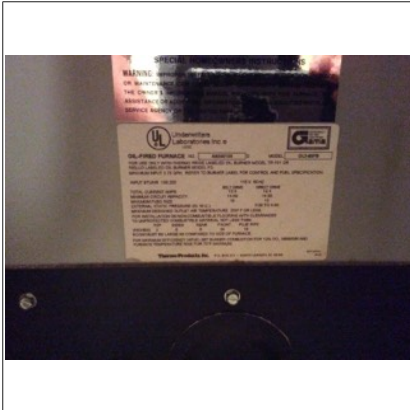
Heating system

Unit #1 Brand name: Thermo
 Approx. age: 15-20+
 Model #: ol5-f58b Serial #: an580159 Satisfactory
Unit #2 None
Energy source Oil
Warm air system Belt drive
Heat exchanger Sealed Not Visible
Carbon monoxide N/A
CO test Tester: TIFF 8800
Combustion air venting present Yes
Controls Disconnect: Yes No Normal operating and safety controls observed
Distribution Metal duct
Flue piping Satisfactory
Filter Standard Satisfactory
When turned on by thermostat Fired Proper operation: Yes No Not tested
Heat pump N/A
Sub-slab ducts N/A
System not operated due to N/A
Photos
